Application Summary

Barnard College in New York City, NY has experienced leaks in the RO water system supporting the Environmental Sciences laboratory. Leaks have been occurring at joints in the fused polypropylene RO piping system.

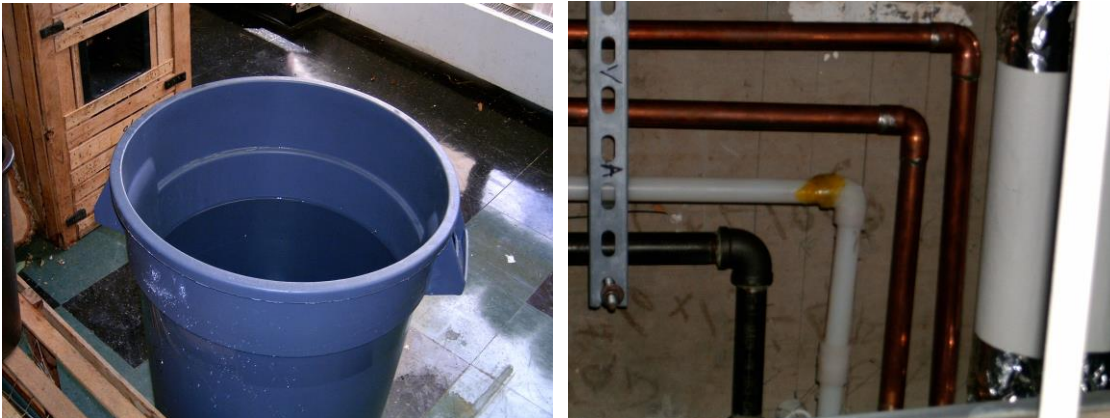
Picture 1: The historic, temporary solution. Picture 2: North Sea Resins Solution

The RO system is a gravity fed piping system that delivers RO water to laboratories on the third floor. Six leaks were found across the floor. All were at joints and all were in the ceiling.

Four of the six leaks were repaired without shutting off the water flow. Repairs done with the water pressure still on took additional time to repair.

Two of the six leaks were repaired after shutting off the water flow. Repairs done with the water shut off were done rapidly with single application of NSR150 resin. These two repairs were each done in 10 minutes.

The surface was wet in all cases. The application procedure was done per the North Sea Resins Technical Information Sheet for NSR150 resin.

The total time to identify and repair all 6 leaks was less than 3 hours. Materials cost for repairing **six** leaks to the fused polypropylene pipes was less than \$150. Prior to leaving the facility all repairs were tested and demonstrated to be “known-good” solutions.
