### *Application Summary*

Barnard College in New York City, NY has experienced leaks in the RO water system supporting the Environmental Sciences laboratory. Leaks have been occurring at joints in the fused polypropylene RO piping system.

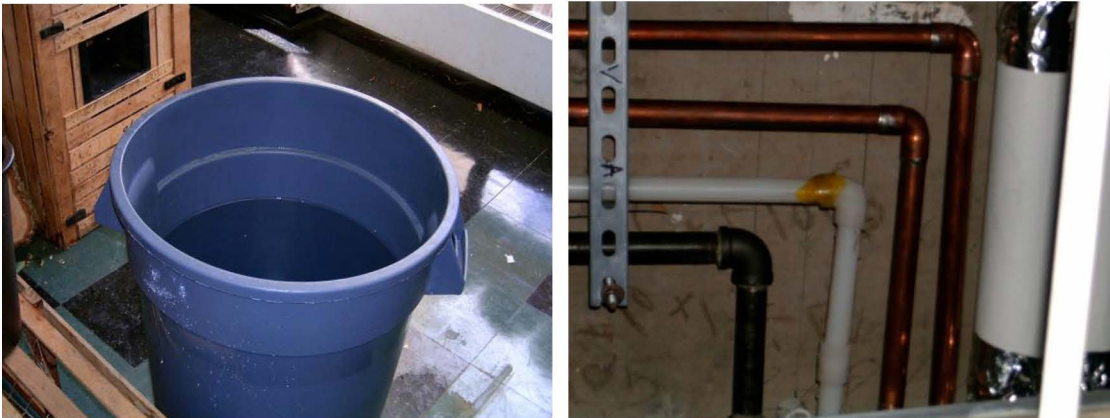
Picture 1: The historic, temporary solution. Picture 2: North Sea Resins Solution

The RO system is a gravity fed piping system that delivers RO water to laboratories on the third floor. Six leaks were found across the floor. All were at joints and all were in the ceiling.

Four of the six leaks were repaired without shutting off the water flow. Repairs done with the water pressure still on took additional time to repair.

Two of the six leaks were repaired after shutting off the water flow. Repairs done with the water shut off were done rapidly with single application of NSR150 resin. These two repairs were each done in 10 minutes.

The surface was wet in all cases. The application procedure was done per the North Sea Resins Technical Information Sheet for NSR150 resin.

The total time to identify and repair all 6 leaks was less than 3 hours. Materials cost for repairing **six** leaks to the fused polypropylene pipes was less than \$150. Prior to leaving the facility all repairs were tested and demonstrated to be “known-good” solutions.
