From: Bruce Cooper, C/E  
MV Tacoma

Date: 02-23-05

Re: North Sea Resins

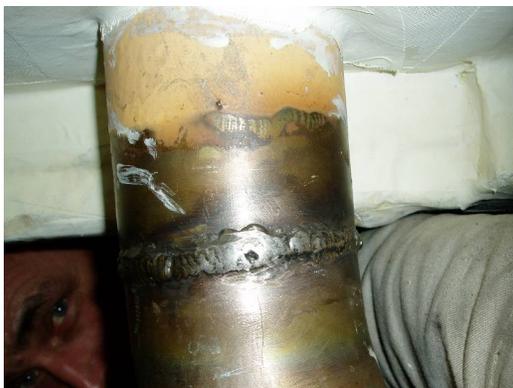
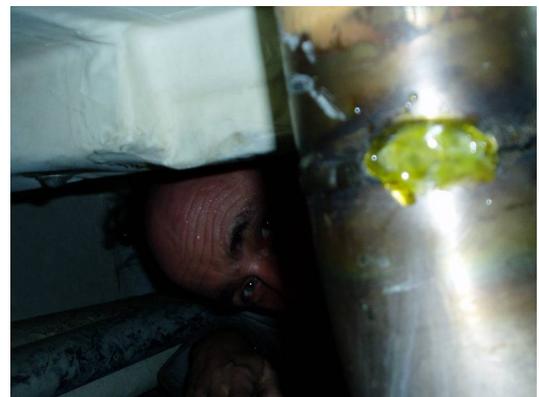
We received a call that water was dripping from a light fixture in front of the 2<sup>nd</sup> Mates door. After pulling the overhead panels we found that a slop sink drain in a Texas deck-cleaning gear locker had an incomplete weld in the pipe. Finding the leak required squeezing into the overhead over some ductwork using a flashlight and mirror. It appeared to have been leaking onto the ductwork for some time.

Before and after shots.

I first used the thin resin to fill the small void, used the blue LED to cure it for one minute. I then used the thick resin to add some body to the patch, allowing the resin to have a larger mechanical bond area. Once again I cured it for one minute. I then attempted to clean up the patch edges by trying to apply the thick resin but successfully dropped the tube between the steel bulkhead and the passenger cabin bulkhead...where it will remain. I applied the thin resin to the patch edges and noted that it started to run down the pipe but was able to quickly LED cure it to prevent the resin from running any further. The patch was applied using a flashlight and mirror thus I would not call it a beautiful patch but it did successfully seal the leak. We were able to test the patch quickly after the patch cured. I was pleased to see that the resin self-life held up well to sitting in the EOS refrigerator for over a year. I sent in a Work Order for repair at our next yard period. I am still waiting for a chance to use this product on a pressurized pipe leak.
